**ARCHITECT'S FIELD REPORT****04**

<b>PROJECT</b>	<b>Ohio City Town Hall</b> Interior and Exterior Rehabilitation, Phase II SHF Project # 2017-01-021	<b>DATE</b>	4/15/2018
----------------	---	-------------	-----------

<b>WORK OBSERVED</b>	
Storefront Window Rehabilitation	
<b>TRADES PRESENT</b>	
Christopher Klein Framing Crew

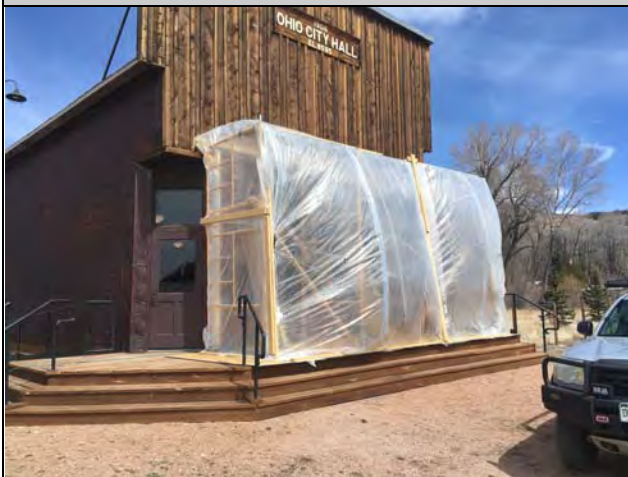
<p>4/15/18 – Photo 1 South Elevation</p> <p>The storefront area has been tented.</p>	<p>Note</p>
 	<p>4/15/18 – Photo 2 Window Frames</p> <p>Two window frames removed from the storefront. The windows frames were single units rather than site built. As such, the window frames were removed as a component.</p>	<p>Note</p>

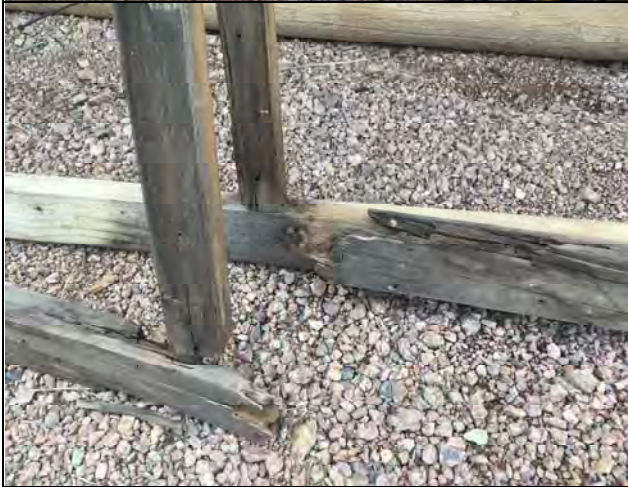
<p>4/15/18 – Photo 3 Window Frame, Sill Detail</p> <p>The window frames are severely degraded and no longer structurally serviceable. The window frames will be replaced with new LVL members.</p>	<p>Note</p>

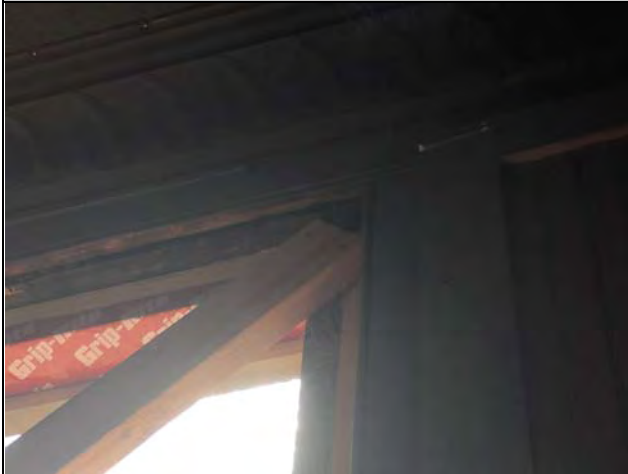
<p>4/15/18 – Photo 7 Interior Cross Brace, Detail</p> <p>Cross bracing has been temporary attached to the top corner of the window frame.</p>	<p>Note</p>

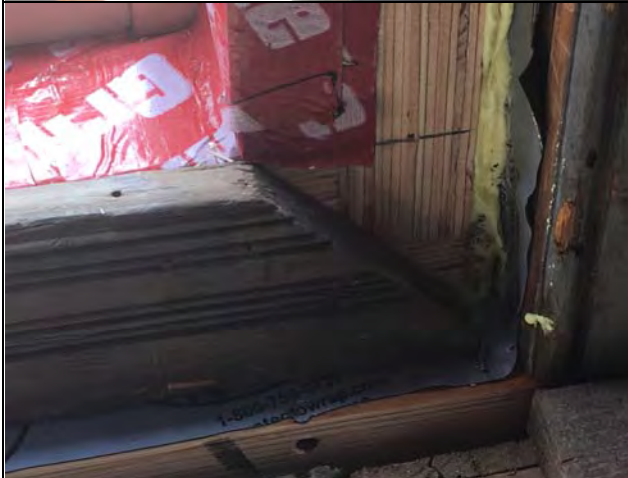
<p>4/15/18 – Photo 8 Interior, Corner Detail</p> <p>Note new pan flashing and new window frame construction. Foam sealant has been used to fill the gap between the new LVL window frame and the pan flashing.</p>	<p>Note</p>

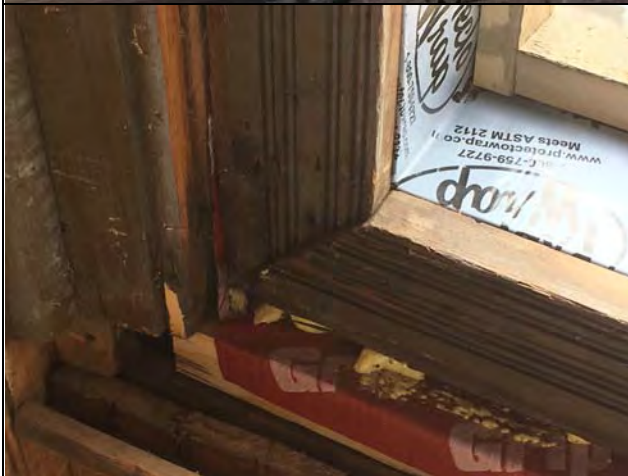
<p>4/15/18 – Photo 9 Interior, Corner Detail</p> <p>Historic interior trim has been reinstalled.</p>	<p>Note</p>

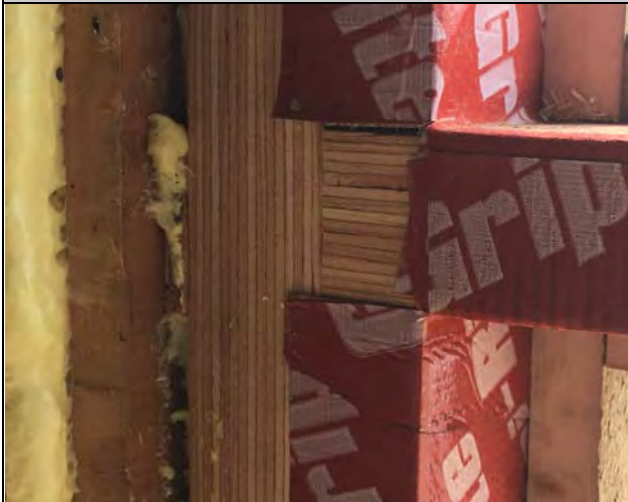
<p>4/15/18 – Photo 10 Interior, Frame Detail</p> <p>Note the use of LVL framing material and waterproof wrap.</p>	<p>Note</p>
 	<p>4/15/18 – Photo 11 Exterior, Detail</p> <p>Detail of the window stops.</p>	<p>Note</p>
 	<p>4/15/18 – Photo 12 Exterior, Corner &amp; Sill Detail</p> <p>Note the new window sill and reinstalled historic trim.</p>	<p>Note</p>

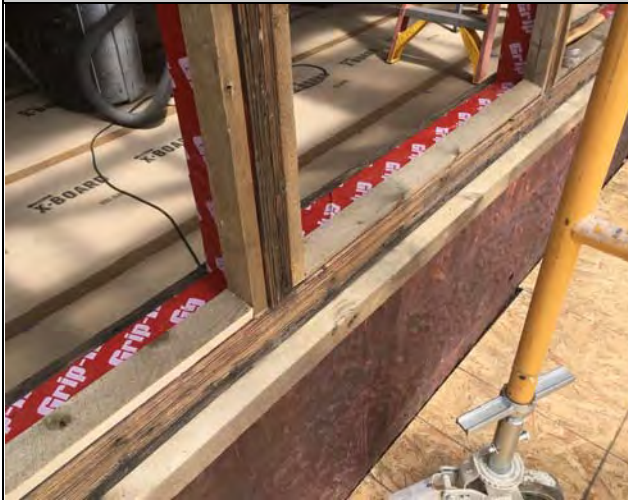
<p>4/15/18 – Photo 13 Exterior, Sill Detail</p> <p>The sill has been recreated with rough sawn material.</p>	<p>Note</p>

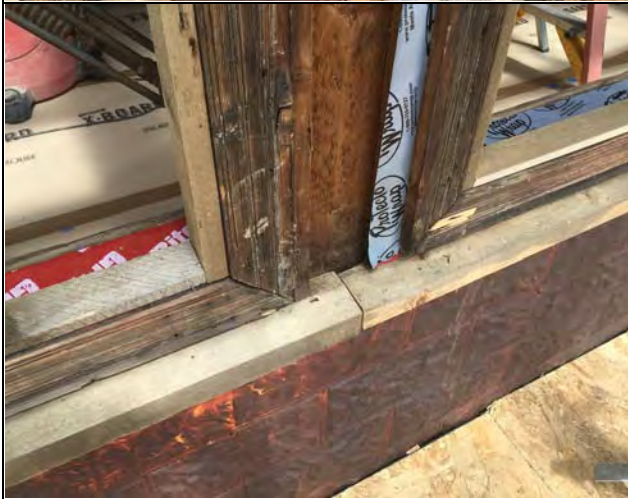
<p>4/15/18 – Photo 14 Exterior, Sill Detail</p> <p>The sill has been recreated with rough sawn material.</p>	<p>Note</p>

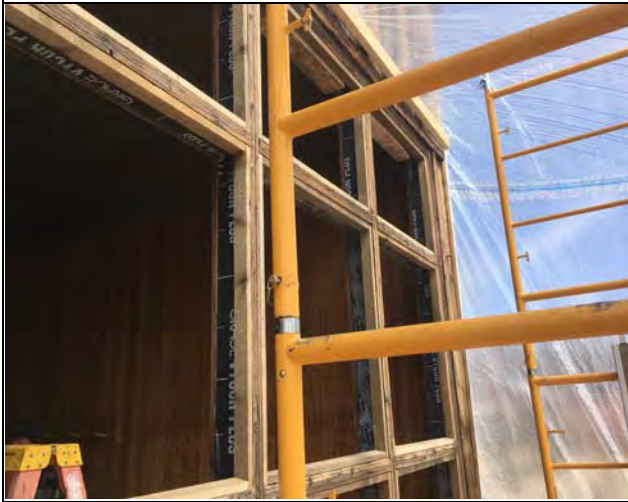
<p>4/15/18 – Photo 15 Exterior, Trim and Stops</p> <p>Completed exterior window stops out of rough sawn material.</p>	<p>Note</p>

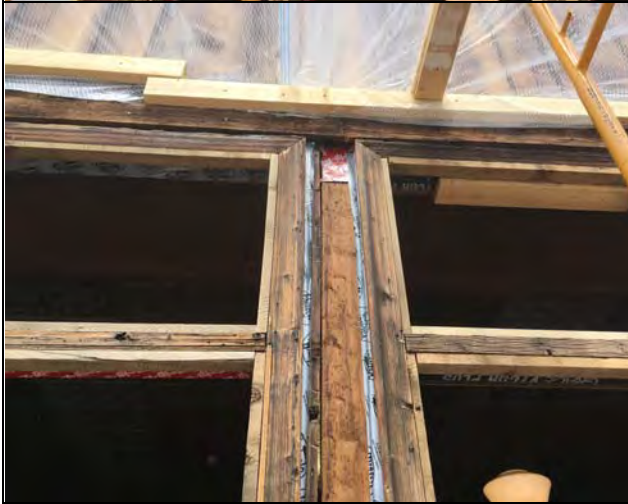
<p>4/15/18 – Photo 17 Exterior, Trim and Stops</p> <p>Historic window trim has been reinstalled. Historic vertical trim boards will also be reinstalled.</p>	<p>Note</p>
 	<p>4/15/18 – Photo 18 Exterior, Sill Detail</p> <p>Note the reconstructed window sill.</p>	<p>Note</p>

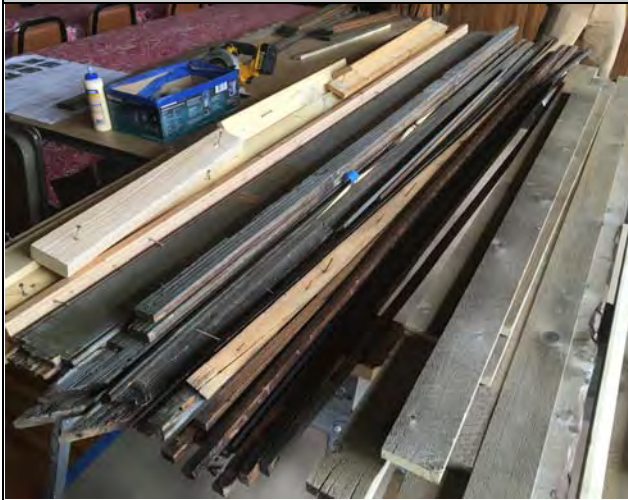
<p>4/15/18 – Photo 19 Interior Trim and Reused Material</p> <p>Material is stored indoors. Interior trim is in the middle. Rough sawn material is on the right.</p>	<p>Note</p>

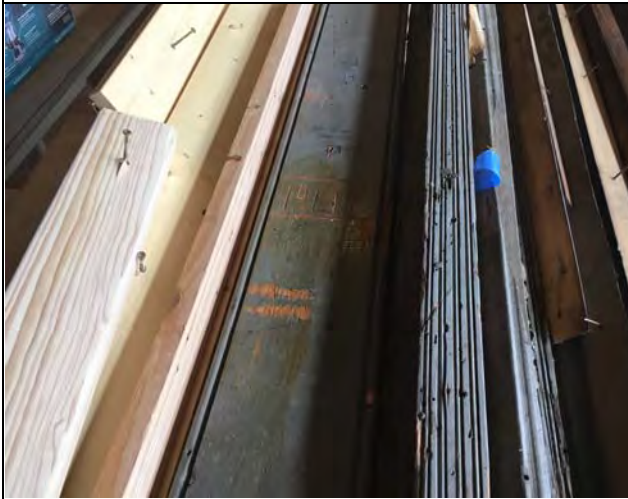
<p>4/15/18 – Photo 20 Detail of Interior Trim</p> <p>Interior trim ready to be reinstalled.</p>	<p>Note</p>

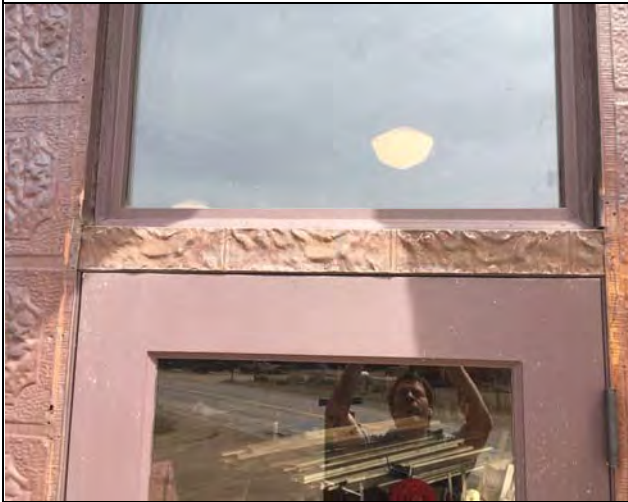
<p>4/15/18 – Photo 21 Detail of Entrance Door Head</p> <p>During strong wind gusts during the site visit, the temporary bracing kept the wall from deflecting. The entry door remained operational.</p>	<p>Note</p>
