FLOODPLAIN INFORMATION REPORT:  
CRYSTAL RIVER  
TOWN OF MARBLE & VICINITY  
GUNNISON COUNTY, COLORADO

August 2004

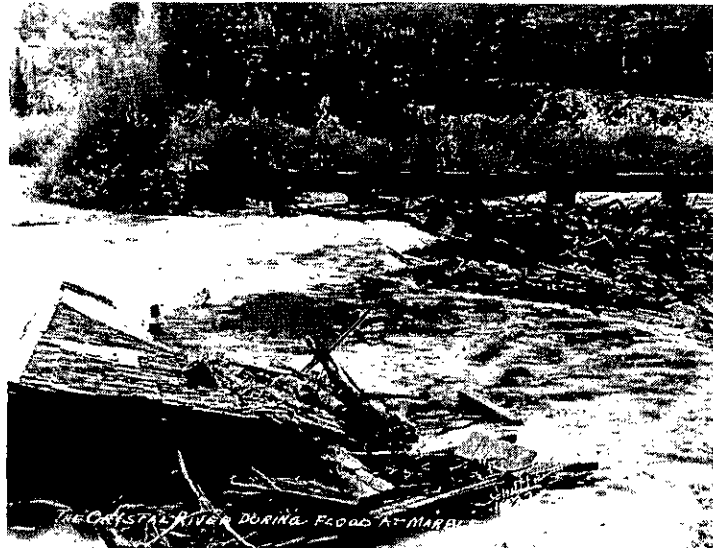
*Figure 1: 1945 Flood Event - Marble, Colorado (Schutte 1945)*

Carbonate Creek, located near the Town of Marble, has a history of rainstorm floods and large mud debris flows. During the August 8, 1941 flood event, a structure, the Horace Williams House, was documented to have moved over 30 feet off of its original foundation as a result of the flooding. Additionally, high

water from the July 31, 1945 storm took out several bridges along the Crystal River from Marble to Carbondale. Photographs of the flood in 1945 are shown in Figure 1 and Figure 2.
